1973 Blue 454 Coupe Restoration

NCRS AUSTRALIA INC CHAPTER NEWSLETTER

1965 Black 396 Coupe Restoration

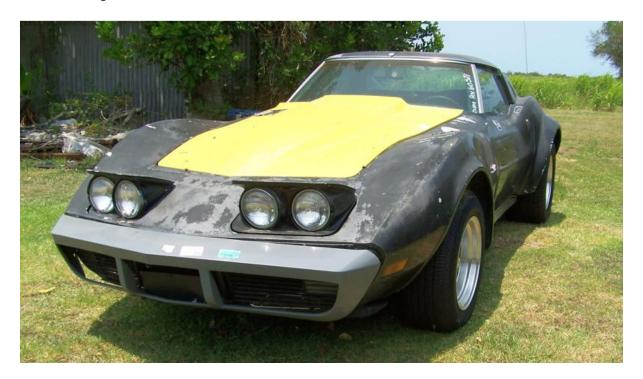
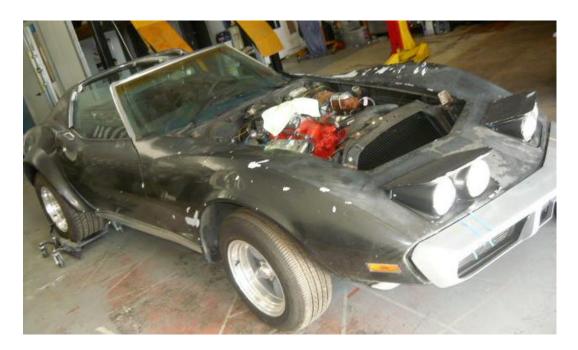
He searched eBay, Gumtree, Car Sales to no avail till late last year he found a 1973 Big Block in a Cane Field in Northern NSW. The Vette seemed to have potential as a restorer, so he decided to fly over east to check it. He quickly determined it was all matching numbers and the chassis was straight with only slight surface rust. The body was modified with the rear fenders flared to fit 10" wide tyres and the wrong hood.

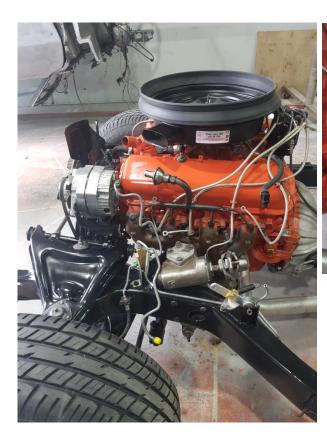
The chassis was completely de-assembled, lightly sand blasted and painted GM Black. All fuel, brake lines, bearings and bushings were replaced.

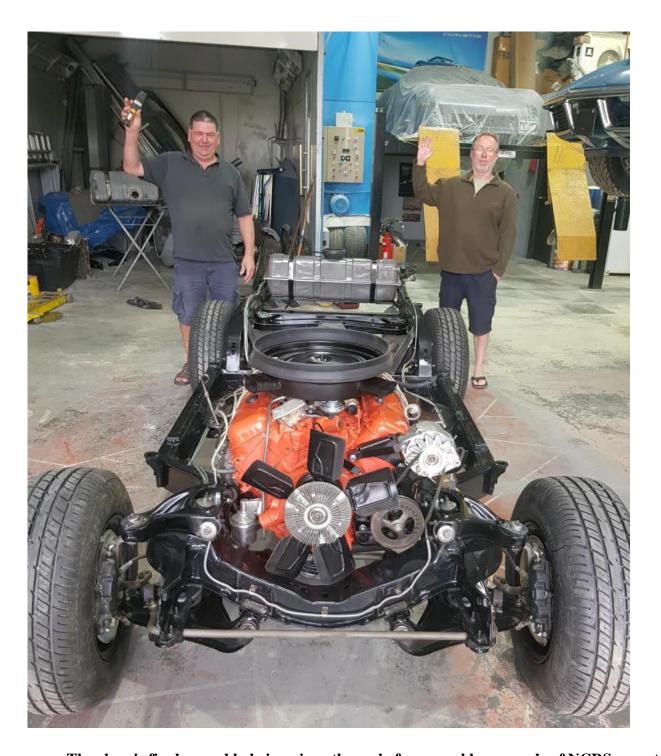
The chassis final assembly being given the seal of approval by a couple of NCRS experts.

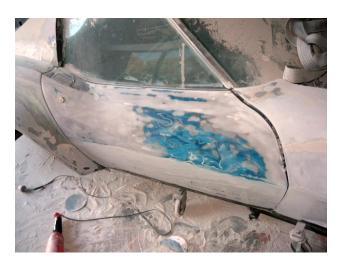
When the body was removed from the chassis the bonding of the top of the front fenders to the birdcage was found to be cracked so the front clip was removed. This also made it easier to access the firewall for restoration.

Paint removal and note top of front fender coming away from the birdcage.

Bonding strip to birdcage repair.

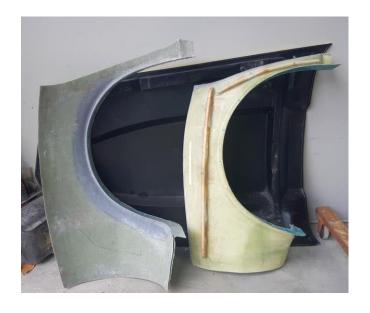
Moulds made by Ron Flood.

Fender panel being removed from the mould

Ron Flood our local NCRS fiberglass expert volunteered to help Terry and take a mould of the rear fenders on a friends Corvette.

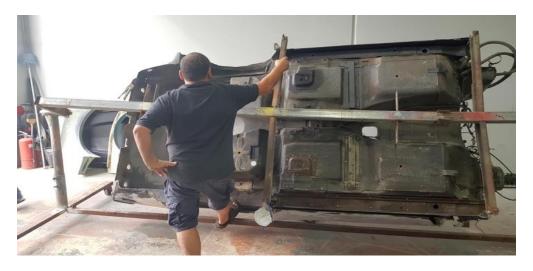
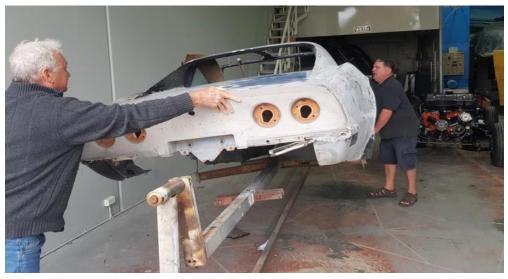
The body was placed on a rotisserie to make it easier to do the fibreglass work to replace the rear fenders.

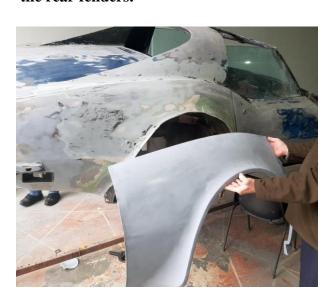
Preparation before rear fender attachment

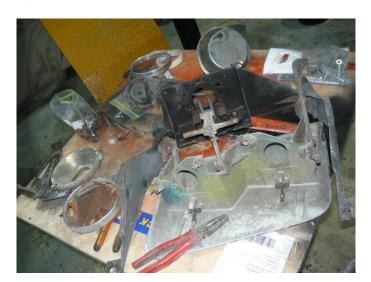
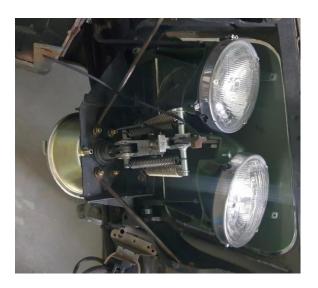
Headlight restoration

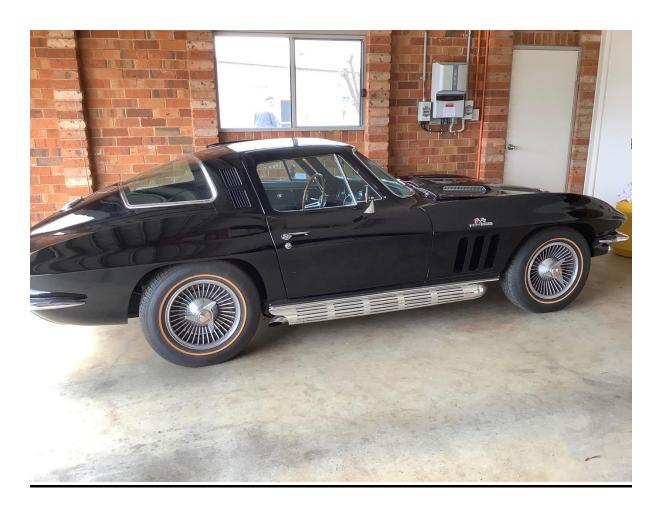
In September 2019, I was contacted by a gentleman, who was thinking about purchasing a 1965 black 396 coupe. So, I was commissioned to inspect the car and give him a full report on it. On inspecting the vehicle, it was found that it was a matching number car. Engine, gearbox, differential all matched the production date of the vehicle. After the evaluation, I classified it as a mid-second flight car, I scored the car at 80.82% The customer then decided to proceed with the purchase of the vehicle and Then after reading my report, he came back to me and asked if I was interested in bringing the car up to a Top Flight standard.

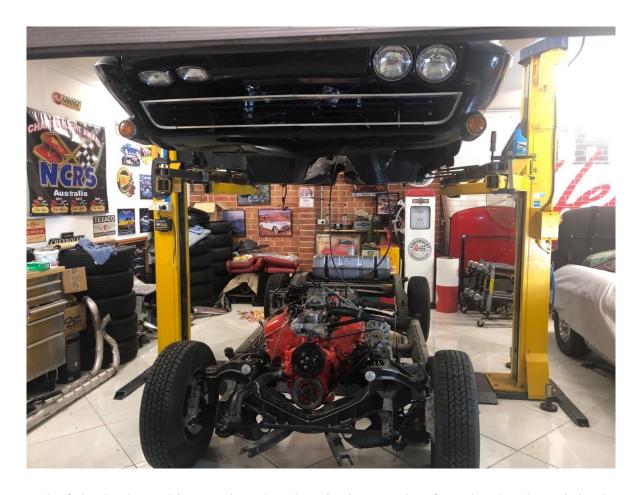
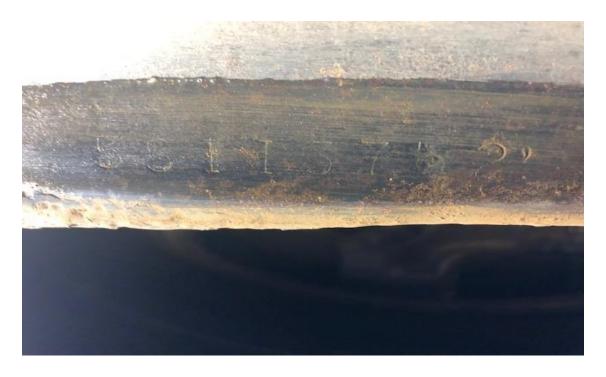
On removal of the body and inspecting the chassis, it was also found to be the original chassis, I was able to locate the stamping on the top of the chassis, over the driver's side rear wheel. 5S113762

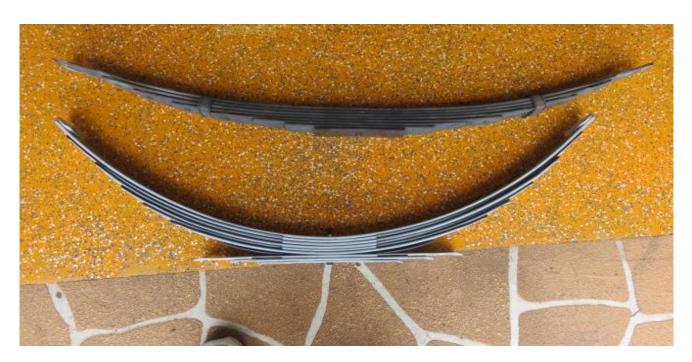
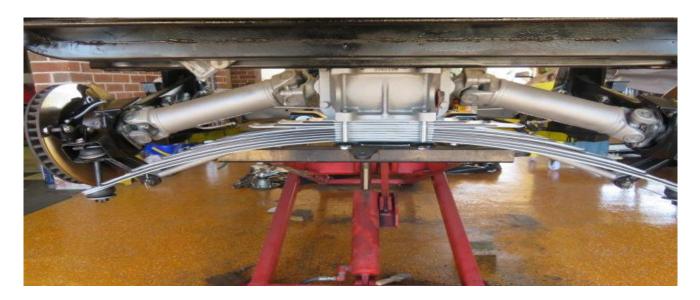
It was also discovered on the disassembly that the rear spring had also been changed to a 7 leaf spring and had started to lose its tension on the drivers side. So, I was able to purchase a 9 leaf spring assy which I then stripped down, clean up, repaint and rebuilt for installation into the chassis.

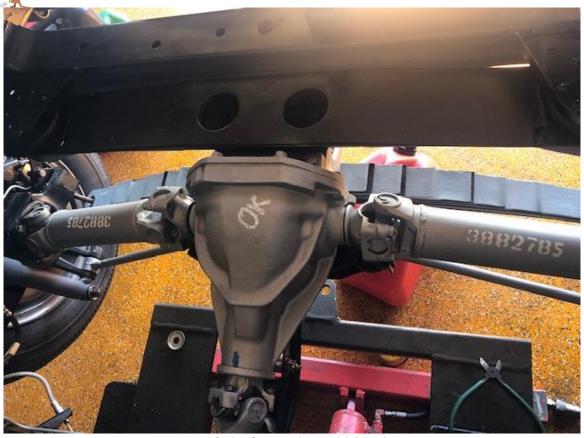
Half shaft numbers 3882785

I then stenciled the half shafts and drive shaft with their production part number, I also the stenciled the chassis number onto the passenger side rear section of the chassis.

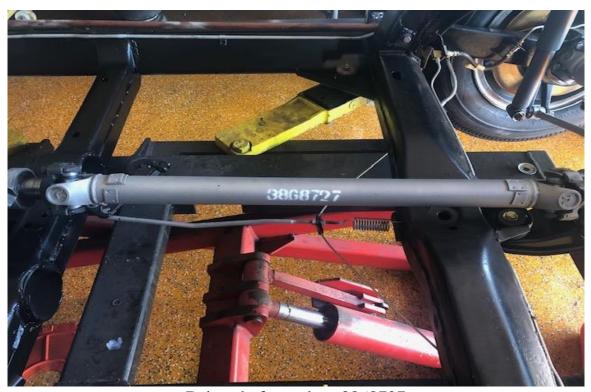
Drive shaft number 3868727

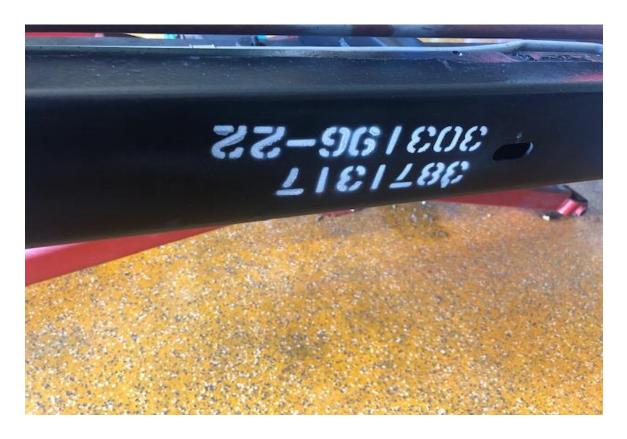
Chassis number 3871317, Production number 303169-22

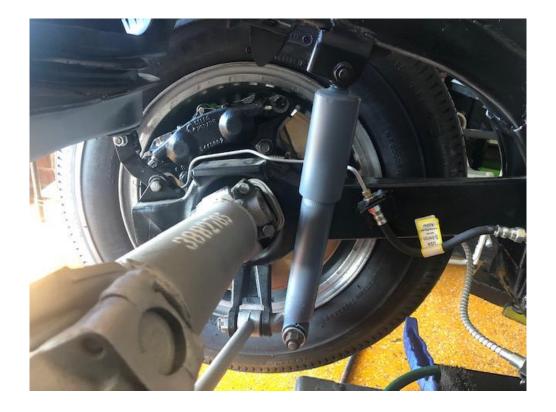
I also installed 4 dated and correct part no; calipers along with 4 dated and part number standard shock absorbers.

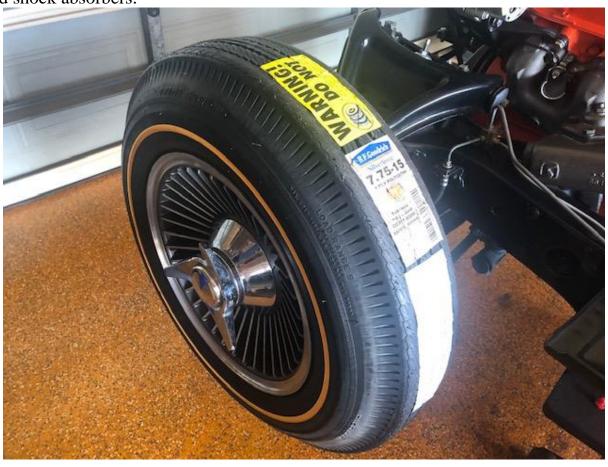
The owner also asked to have period correct tyres and tar-top battery installed.

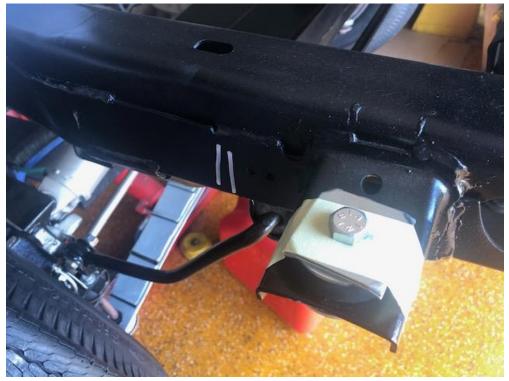
I have now installed all the new shims and rubber body mounts, held in place by an inch and quarter tape, same as they used in the factory. The chassis has been marked with corresponding markings of each shims used at the mounts.

Rear Drivers side mount 2 shims used

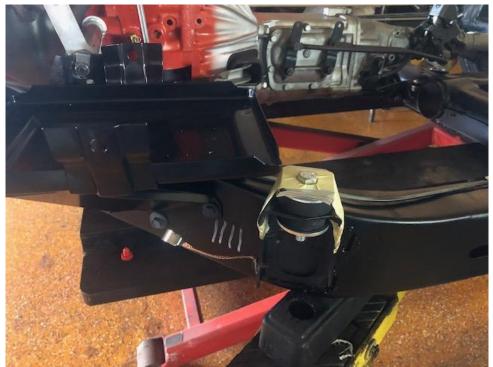
Front drivers side mount 4 shims used along with the tape and earth connections.

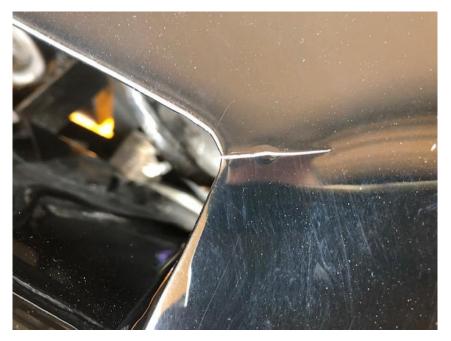
On inspecting the body, it was found that there were 2 very large cracks at the base of the rear window on both sides. Along with cracks on the corner of the headlight buckets and above the driver's side front windscreen.

Note the cracks at base of windows

It was decided to take the car to a professional fiberglass repair person. I have dealt with him in the past, in my marine connections, so Bob was the ideal person to do these repairs. He ground out all the cracks, fiberglass both sides, re-gel coated and painted with an undercoat ready for the car to be resprayed.

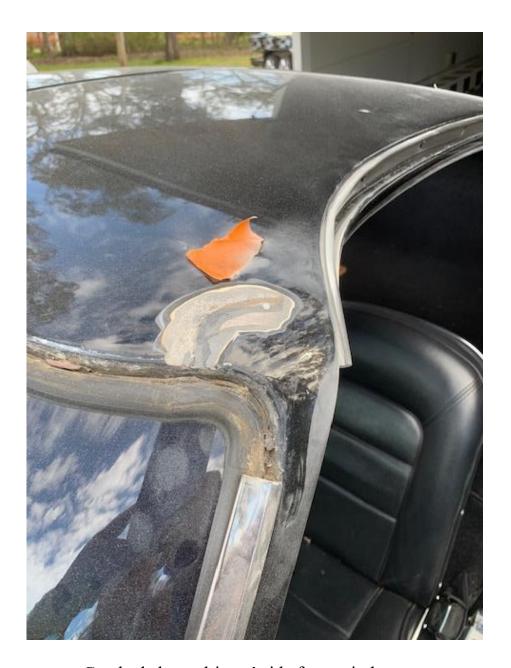
Also cracks on corners of both front headlight buckets

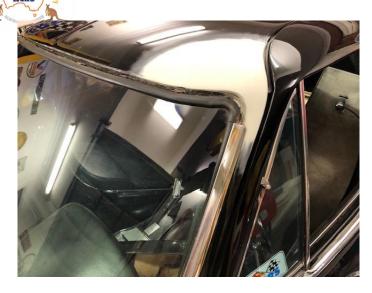
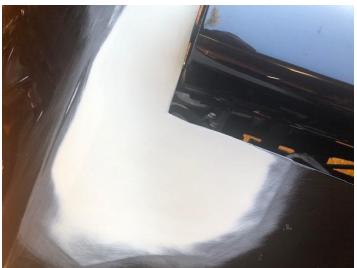
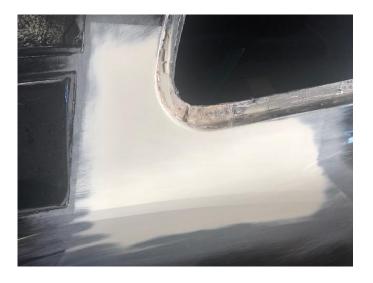
As you can see, all the repairs have been done and prepared for repainting.

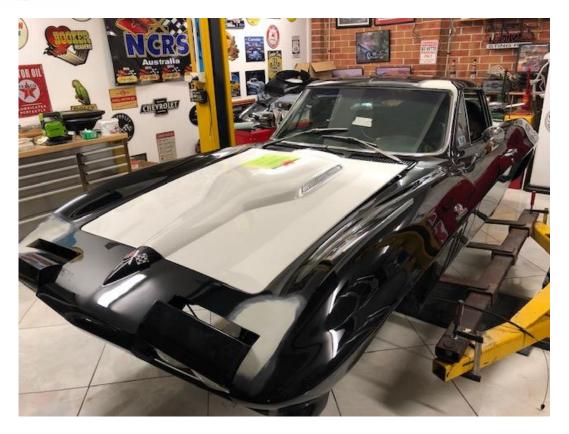
On inspecting the hood, it was found to have many repairs carried out on the underside. It had also delaminated from the top assy, and rather than try to repair, it was decided to purchase a brand-new hood.

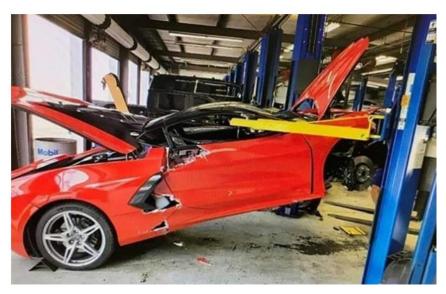
C8 Corvette falls of lift in Dealership

It was just about a month ago that Corvette Blogger contributor Jeremy Welborn offered up this video on the proper jack and lift points for the 2020 Corvette after witnessing a video showing the C8 Corvette that was lifted in the wrong place. Because the weight distribution is now 40/60 with the engine behind the driver, you have to have the jack or lift mounted to the chassis locations properly or the unthinkable could happen as the lift is raised.

Unfortunately, this happened late last week as the owner of a new 2020 Corvette Stingray whose claims that techs at a Chevrolet dealership in Jacksonville improperly lifted his car which resulted in the car falling off the lift and landing hard on the shop floor. The impact caused body damage to the car and broke out the windows.

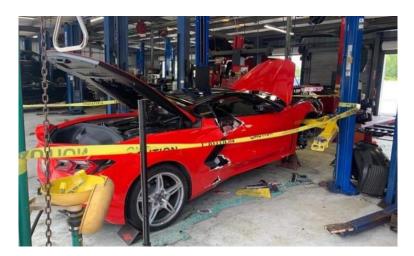
To add insult to injury and unbeknownst to the owner, photos of the wrecked Corvette were shared to Instagram leading the owner to post "That's my f@#%ing car, how the hell did this get on Instagram?" asks Jake Miller, the owner of the Torch Red Stingray. He added that it's "not a broken lift; dumb@sstechs that put it on the lift improperly" is what caused the Corvette to fall off the lift.

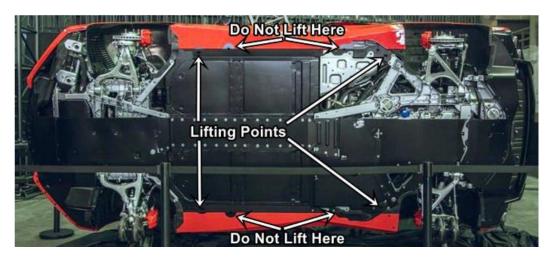
In Jeremy's video from March, he also shares this photo from the reveal of the 2020 Corvette that shows the proper jacking locations. It appears that some are confused by the punchouts on the frame rail where our graphic is marked "Do not lift here":

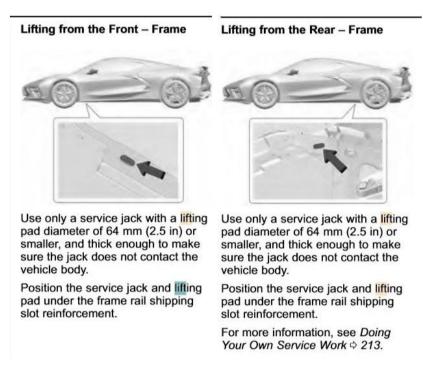
Here is the actual page from the <u>2020 Corvette Stingray's Owner's Manual</u> about utilizing the proper locations for lifting your car:
